# Manhole Inspection Summary

Manhole # S23KK1027MH

Insp Date: **11/8/06 1:10 PM**

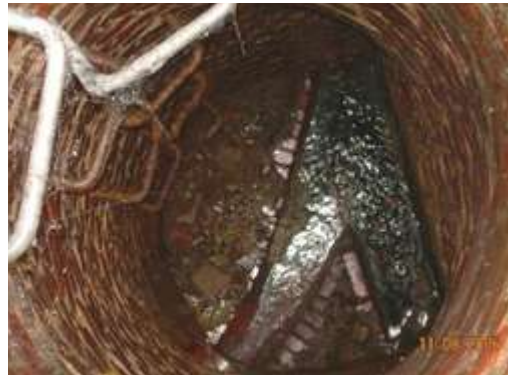
Top View

Condition: ☐ Sound ☐ Cracked ☐ Root Intrusion ☐ Deteriorated ☐ Leaks ☒ **Debris**

**Steps** Count: **8** Missing: **0** ☒ **Corroded**

Corroded steps. Bench and Channel debris.

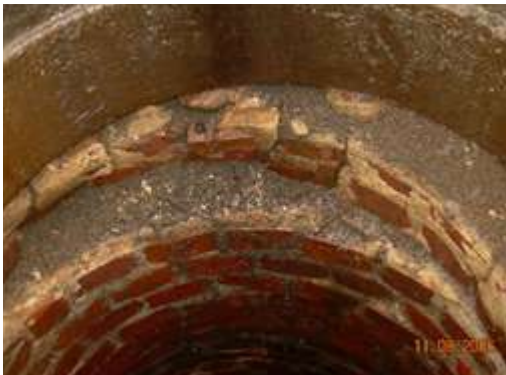
Defect

**Frame** Offset: **4** (in.) Condition: ☐ Sound ☐ Cracked ☒ **Leaks**

Condition: ☐ Sound ☐ Cracked ☐ Root Intrusion ☐ Loose Brick ☒ **Deteriorated**

Infiltration: ☐ None ☒ **Joint** ☐ Cracks ☒ **Mortar** ☐ Roots ☐ Wall

Frame leaks. Adjustment deterioration and infiltration.

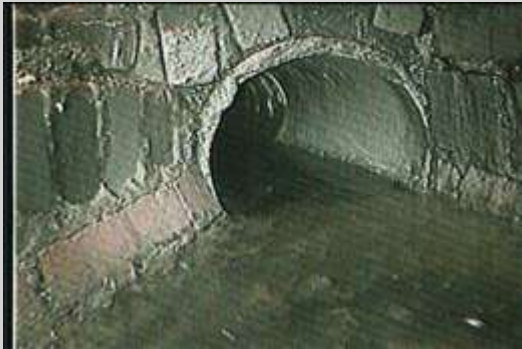
### 10 in. Circular Gravity Sewer Pipe Out @ 12 O'Clock

Infiltration: **None** Pipe Seal Cond: **Unknown**

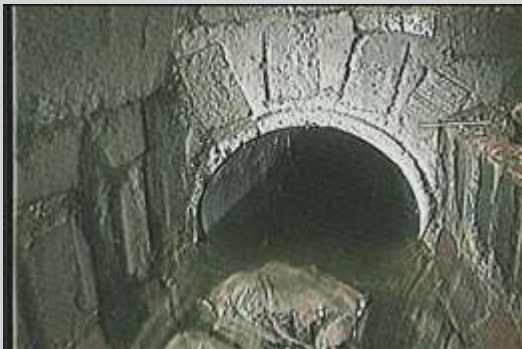
### 10 in. Circular Gravity Sewer Pipe In @ 6 O'Clock

Infiltration: **None** Pipe Seal Cond: **Unknown**

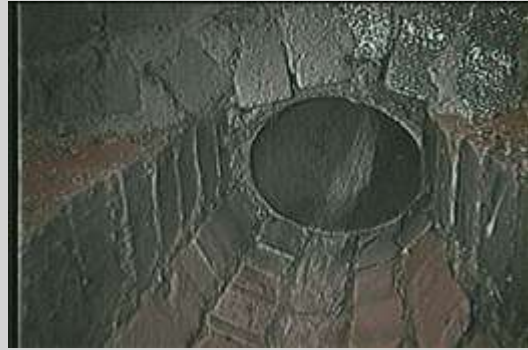
Drop In @ 8 O'Clock

Channel deterioration.
